### **Report of Findings**

STRUCTURAL EVALUATION Claim No: 1002259499

RCG File No: 22804649

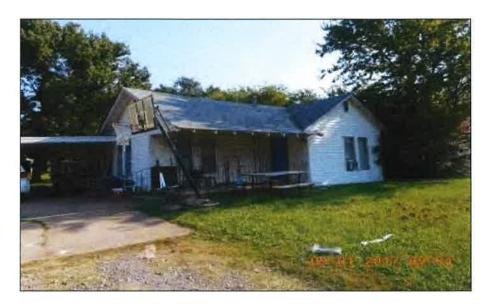
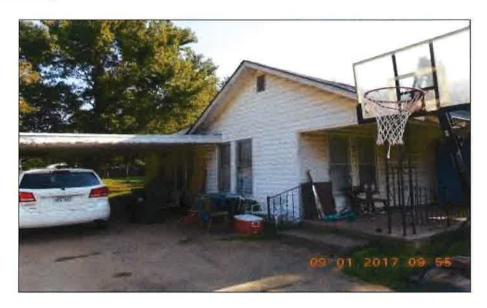
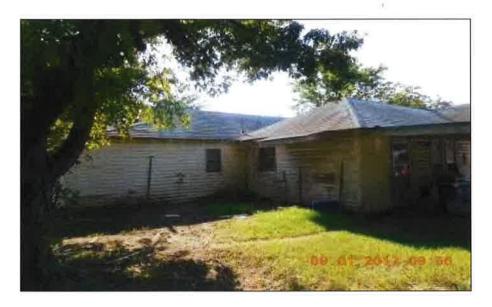
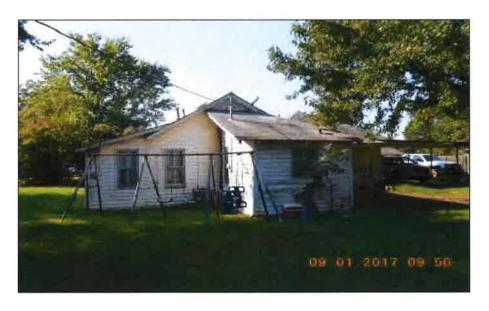
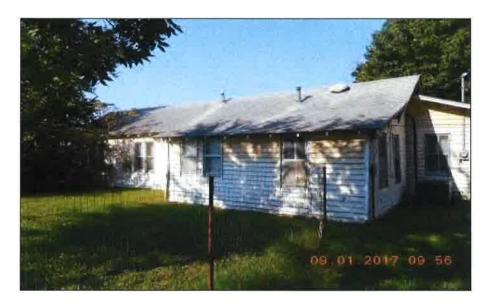
The residential property was a one-story, wood-framed dwelling covered with vinyl siding on the exterior. The foundation was a combination shallow foundation perimeter walls of an unknown material with portions of concrete slab foundation added later. The interior wall finishes were a combination of lath and plaster and drywall with paint. The ceiling was furring strips with acoustical ceiling tiles. The flooring was a combination of carpet and vinyl flooring. The roof covering was asphalt shingles. For the purposes of this report, the side of the residence with the front entrance door faces south, refer to (**Photographs 1 through 5**).

Photograph 1 South side.

Photograph 2
Front east side.

Photograph 3
Rear east side.

Photograph 4 North side.

Photograph 5 West side.

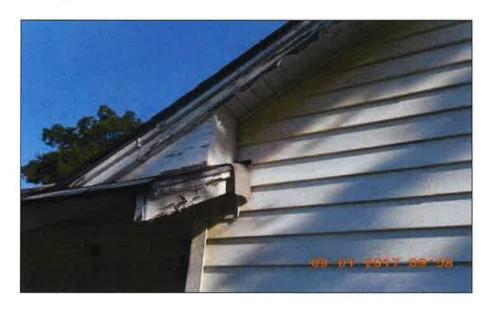
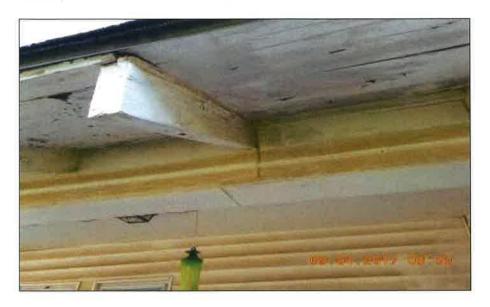
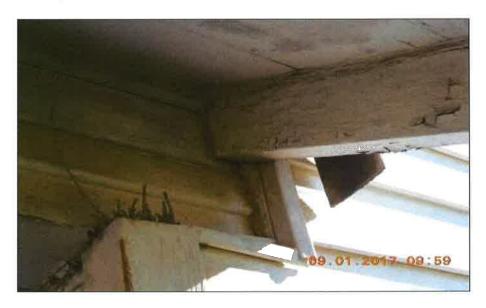
- The roof rafter connections to the wall framing were observed to be intact and without separation. Roof framing locations that did have cracks or separations were observed to have dust and cobwebs within the separations (Photographs 6 through 8).

The uneven floor was determined to be caused by differential foundation movement. The crack along the wall and leaning wall were determined to be caused by a poorly constructed floor extension consisting of an added footing adjacent to an interior slab. Other interior cracks showed signs of age and contained no stretched or cracked paint. The residence was out of plumb in several locations with the cause being differential foundation movement. Horizontal cracks were observed in the driveway slab and the front porch. These cracks showed signs of age and were consistent with shrinkage cracks and differential foundation movement cracks. Furthermore, cobwebs and insect nests were observed in several of the separations indicating they were not recently formed.

Photograph 6
Roof connection.

Photograph 7
Roof connection.

Photograph 8
Roof connection.

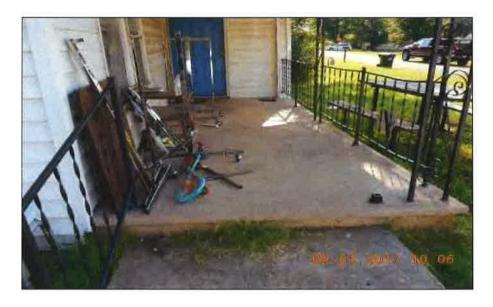
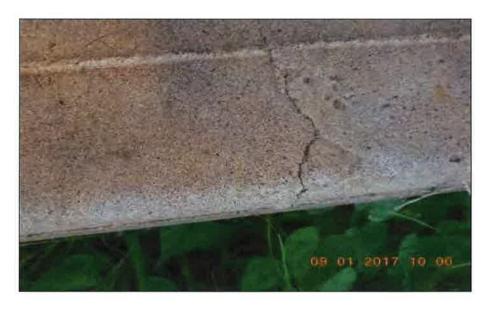
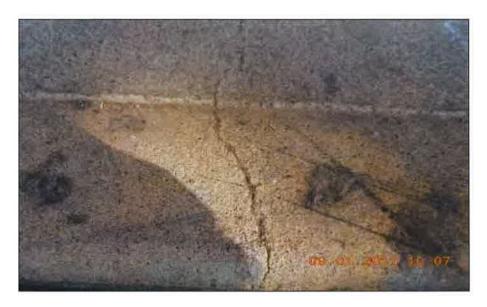
- The slab supporting the front porch contained cracks. The stem wall was covered by the vinyl siding (Photographs 9 through 11).
- Cracks existed in the driveway slab under the carport. The cracks contained dust and showed wear over time along the edges of the cracks.
   (Photographs 12 through 14).

Photograph 9 Front porch.

Photograph 10 Front porch crack.

Photograph 11
Front porch crack

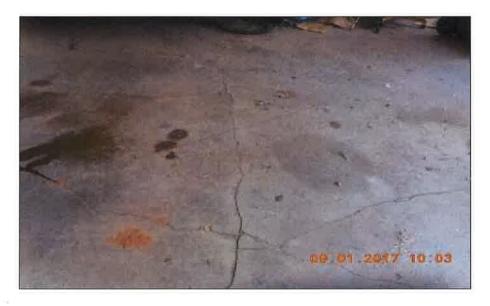
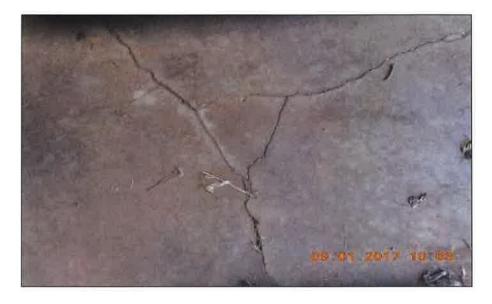
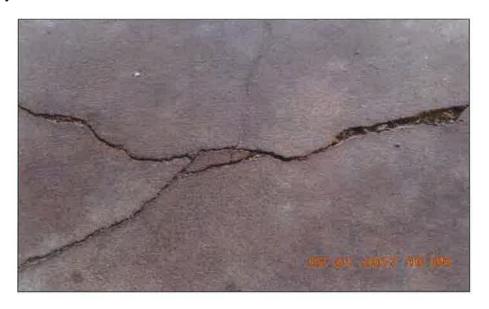
The origin of the damage observed to the floor, ceiling tiles, and driveway slab under the carport was from differential foundation movement related to volumetric soil changes from soil moisture variations over time. This is shown by the floor elevations that demonstrate variation in ground movement over an extended period of time. Poor construction techniques found at the foundation contributed.

Photograph 12 Driveway crack.

Photograph 13 Driveway crack.

Photograph 14 Driveway crack.

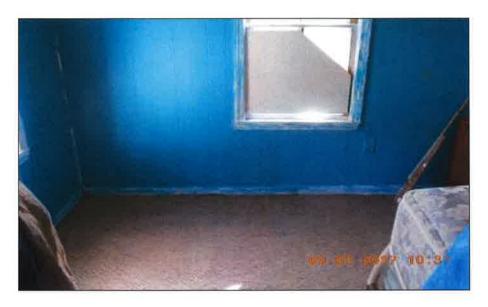
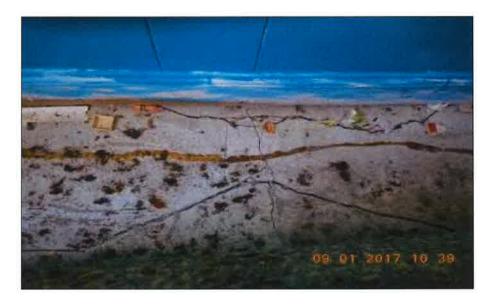
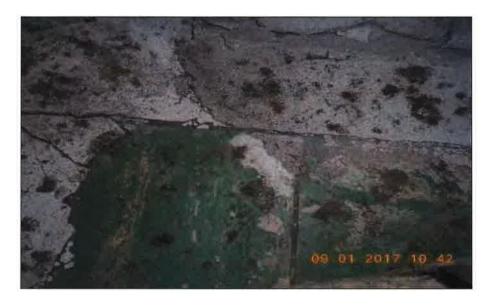
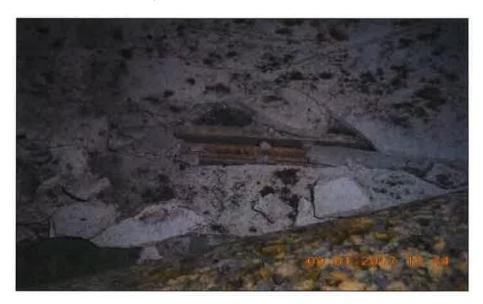
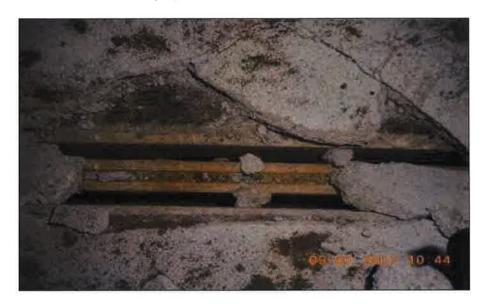
- The floor inside the residence had several areas of bowing (Drawing Attachment B).
- The carpet was pulled back in the son's bedroom, and the concrete under the carpet was examined. The concrete had an area where it had been patched. It was cracked and broken. Examining below the broken pieces of concrete, it was determined that the room was extended at some point and a new strip footing had been added, and there was plywood incorporated in the footing. (Photographs 15 through 19).

Photograph 15 Son's room.

Photograph 16 Son's room floor under the carpet.

Photograph 17
Son's room floor under the carpet.

Photograph 18
Son's room floor under the carpet.

Photograph 19 Son's room floor under the carpet.

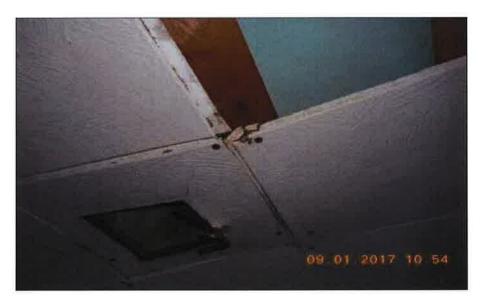
• It was observed that the ceiling in the bathroom and son's bedroom had ceiling tiles that were missing. Repairs of these tiles were observed to be aged (**Photograph 20**).

Photograph 20 Ceiling tiles.

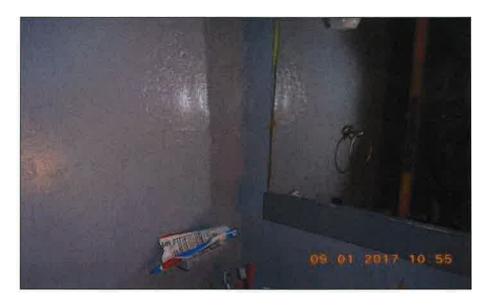
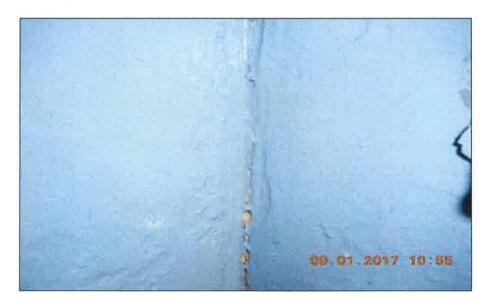
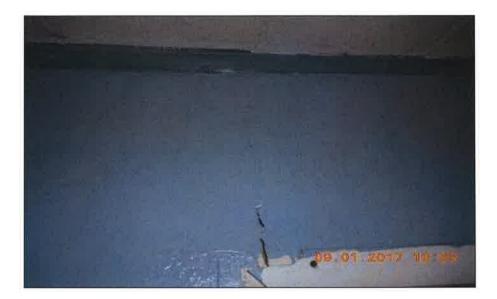
Several cracks were noticed throughout the residence. All were observed to have paint inside the cracks (Photographs 21 through 23).

Photograph 21
Bathroom cracks.

Photograph 22
Bathroom cracks.

Photograph 23
Bathroom cracks.

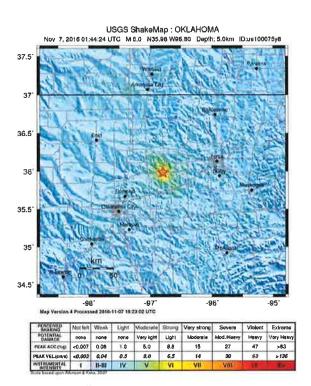
### **Shake Map Information**

A review of the shake map on the USGS website indicated that the November 7, 2016, seismic event resulted in the following at the subject property (**Attachment C**):

- Peak Acceleration (8.8 second) of 1.0 percent of gravity.
- Peak Velocity of 6.5 centimeters per second.
- Instrumental Intensity VI.
- Instrumental intensity VI seismic events result in strong perceived shaking and light potential damage.
